Paper M 1

## SEASONAL CHANGES OF LITTORAL TRANSPORT AND BEACH WIDTH AND RESULTING EFFECT ON PROTECTIVE STRUCTURES

Turbit H. Slaughter, Geologist, *Maryland Geological Survey, The Johns Hopkins University, Baltimore, Maryland*

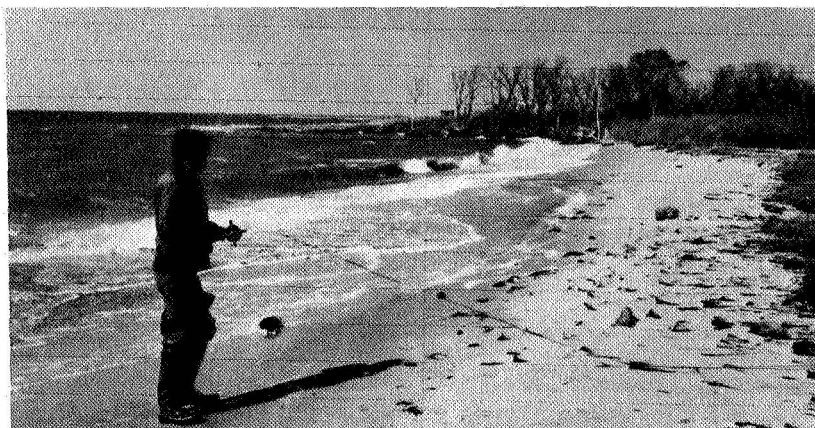
Figure 2 April 29, 1971

A study of the geomorphologic problem of a former spit that now serves as a barrier beach extending along the southern boundary of Janes Island State Park, Somerset County, extends slightly southeastward of Island Point a distance of 4,800 feet, disclosed two apparent but different types of littoral data. During the summer months, due to winds blowing from the southwest across Tangier Sound moved sand northward to a cove bordered by scrub size trees. There was no beach in front of the thick deep rooted organic marsh vegetation. Wave action would break chunks of the vegetation mass up and through them up on the shore. During the winter months the winds from the northwest would move the sand southward and by late spring there would be a sand beach completely covering and protecting the summertime eroding marsh shore edge. The erosion rate of this location is 1.5 feet a year, a relatively low rate, but understandably so. A time sequence of April and July, is shown by Figures 2, and 3.

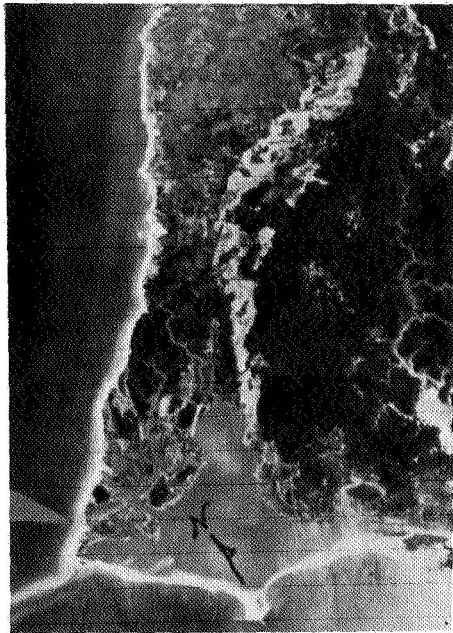
Figure 4. Janes Island  
ERTS-1 Mission 16  
Underflight Oct. 20, 1972.

Through the inspection of the ERTS-1 film, these facts are documented by Figures 4 and 5, which are photo copies of ERTS-1 underflight mission 16, October 20, 1972, and mission flight 226, January 16, 1973, respectively. Unfortunately flights earlier than October are not available. The fall-winter littoral transport direction southward began before October 20, as evidenced by mission 226 flight. The color IR film definitely delineates the sand shoreline separately out the ice, while the color positive film shows the offshore bar and trough structures which the color IR does not.

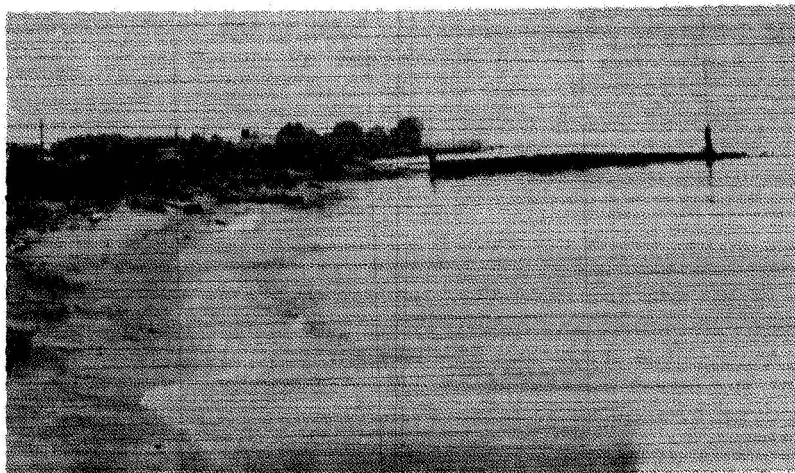
Figure 6. North Mile Marker - Kent Island - August 3, 1971

A second example area for which the Survey has pre and current ERTS-1 ground truth is the northern marker of a measured mile on Kent Island, Queen Annes County. During the summer months sand accumulates on the southern side of the groin to which the marker is attached, causing a starvation of the northern shoreline. The process is reversed in the winter; erosion rate is measured to be 5 feet a year. Figure 6 shows the summer starved condition and Figure 7 shows the winter buildup. This situation could be prevented by elimination of the groin. ERTS-1 underflight film mission 215 from an altitude of 10,000 feet dated September 23, 1972, is shown in Figure 8 and the January 16, 1973 flight is shown in Figure 9. The arrow points to the groin. The ERTS-1 film clearly shows this littoral reversal.

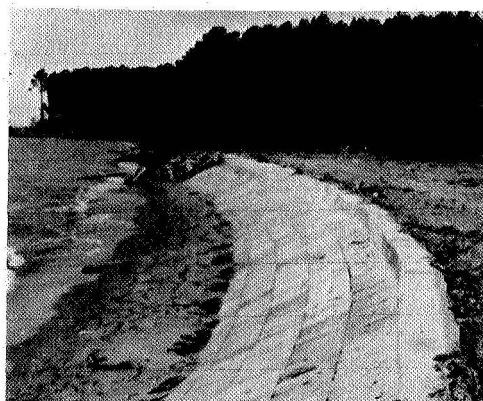
Figure 10. S. Tilghman Island  
Sept. 26, 1967

Construction was begun in April, 1966 and completed in September, 1967. The first section of structure was keyed to the northern end of the Navy steel bulkhead and consists of 270 feet of timber bulkheading, reinforced at the toe with 1/4 ton rip-rap. The remaining 730 feet was protected by a sloped revetment of interlocking concrete blocks. The use of concrete blocks in revetment design has been documented by Hall, J. V. and Jachowski, R. A. (1964) and Hall, J. V. (1967). The revetment at Tilghman has been described by Mohl, E. V. and Brown, J. D. (1967) and Slaughter, T. H. (1967).

Background knowledge of offshore and onshore conditions of the area indicated a high hydrodynamic environment, with little or no beach during most of the year. The offshore was shallow cored, indicating a predominant sandy bottom which could serve as a source of littoral material, especially during the winter months. By the spring of 1971 it was apparent that for a number of reasons, the northern 200 feet of the concrete block revetment was in trouble, the toe of the structure was being undermined. As a result of toe undermining, the structure failed along this section. (Figure 10 shows the northern end of the structure on September 26, 1967 shortly after completion. Figure 11 shows the same location on October 4, 1972.)

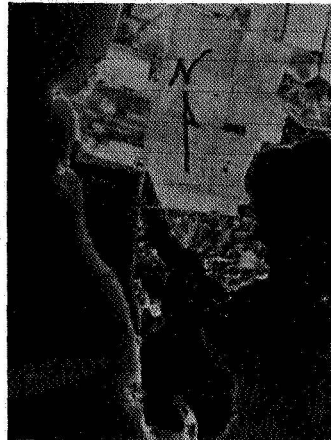
Figure 12.

Inspection of ERTS-1 low altitude flight film, Color IR of October 20, 1972, Figure 12 and January 16, 1973, Figure 13, and color positives of January 16, 1973, does not show any beach for the 3,800 feet under consideration. The lack of winter sand accumulation as shown by the January 16, 1973 flight may not be the usual situation as sometimes is the case, but it emphasizes the fact that there is very little beach sand to be counted on to protect the toe of the revetment.

S. Tilghman Island  
ERTS-1 Mission 16  
Underflight  
Oct. 20, 1972

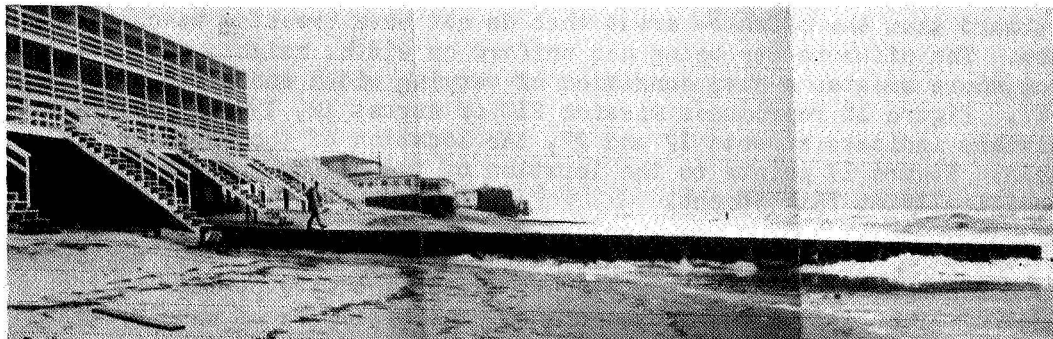
Figure 14. Ocean City, 75th Street February 7, 1973

Of concern is the effectiveness or non-effectiveness of the groin fields and individual groins. Winter northeast winds take their toll of the beach and in some cases the dune is under extreme high tide attack. (Figure 14 dated February 7, 1973, shows weak beach conditions at the 75th Street groin.

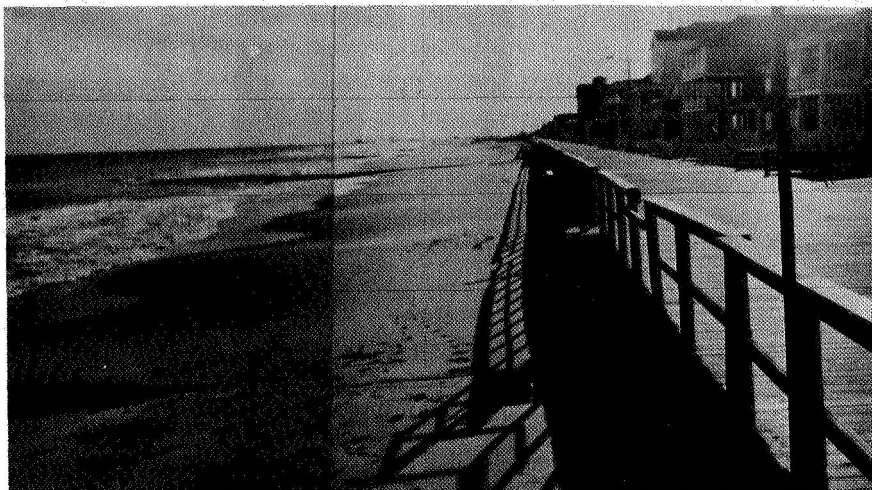
Figure 15. Ocean City, 13th Street      October 17, 1972

Figure 15 shows the beach conditions at 13th Street on October 17, 1972. The groin in the foreground is completely exposed and high tide reached under the base of the boardwalk.

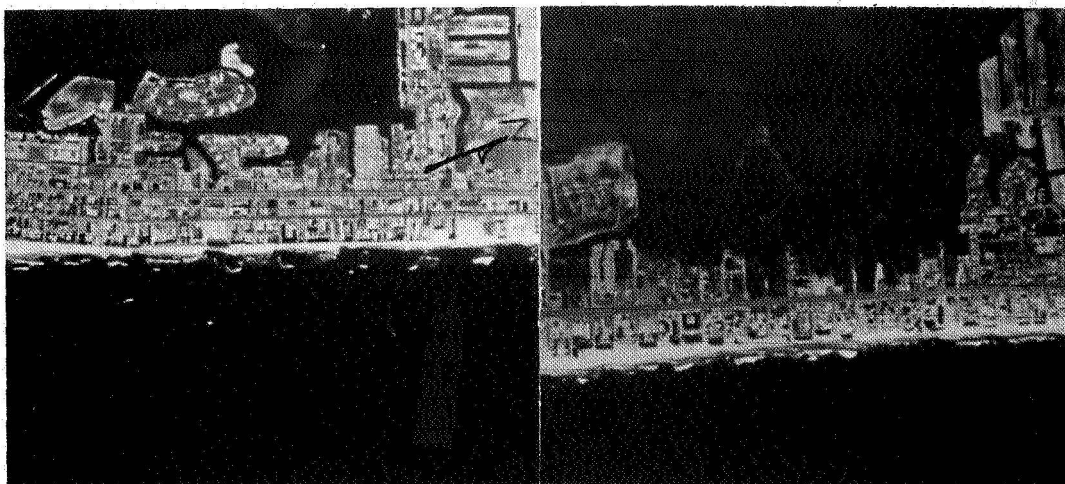
Figure 16. South Ocean City  
ERTS-1 Mission 210

Available offshore profiled data obtained by the U. S. Army Corps of Engineers along Ocean City beach show the nearshore bar to vary in width and height and distance from shore. Personal knowledge of Ocean City summer beach swimming conditions, documents the existence of rip currents, when along shore currents are increased. ERTS-1 underflight low altitude film of mission 210 on August 12, 1972, disclosed very clearly, the apparent relationship of the offshore bar to the beach. The day was a fairly normal summer day weather-wise, winds started off in the morning from the north and swung around to the southeast later in the day. Maximum wind was 6 to 10 mph. The minimal offshore wave breaking pattern of the day disclosed that where the waves break the shoreline is farther eastward than the offshore areas that do not have breaking waves facing them. The offshore bar being non uniform on width, height, and distance from shore creates a cusp condition of varying width and depth of enlargement. Figure 16 reproduces mission 210 of August 12, 1972. The numbered pointers indicate streets 12 and 27, the location of the southern groin field. Figure 17 points to the location of the northern groin field, specifically at 75th Street.

Mission 226 low altitude underflight of January 16, 1973, duplicates the essence of August 12, 1972 flight, except the wave pattern of the January flight is a little more intense, therefore, exact wave breaking patterns are not discernable.
